CIVIL ASSESSMENT

Nitsch Engineering's observations and findings are summarized below.

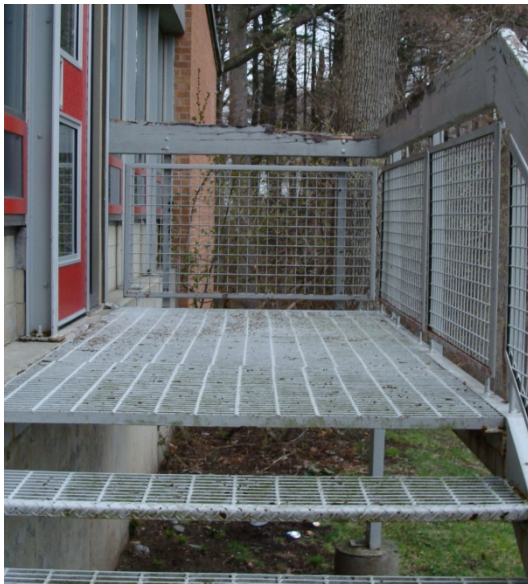
Concrete retaining wall and amphitheater (Image 2) is in fair condition with evidence of parging and repairs and some failure evident.

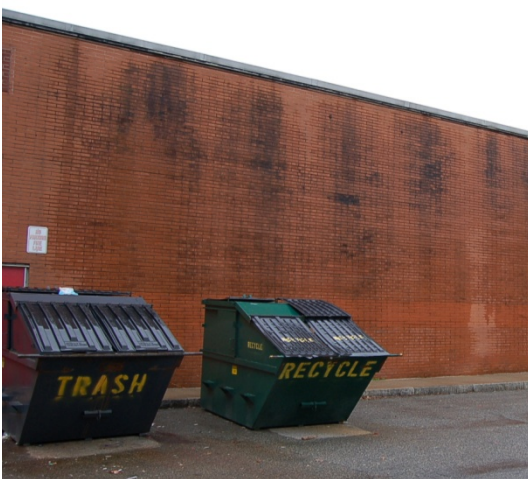
The 1969 exterior walls have some brick veneer and wood siding but is mostly constructed of aluminum storefront system with metal and spandrel panels and insulated glass. These were installed during the 1992 improvement project.

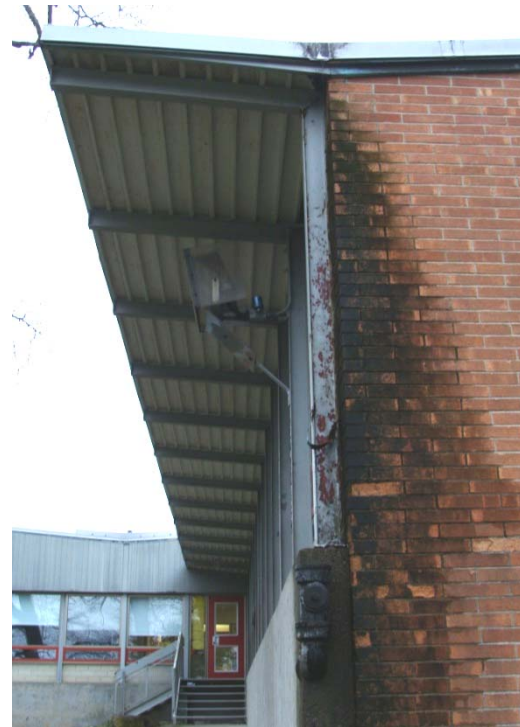
The concrete retaining wall should be reviewed on an annual basis for repair and sealing of the concrete.

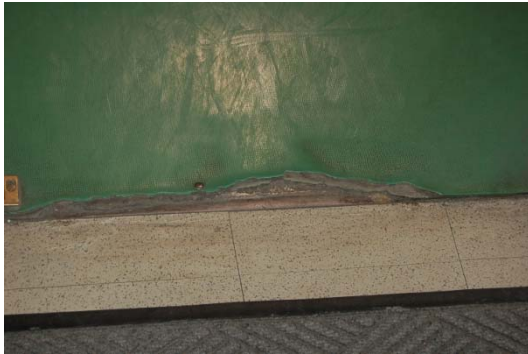
Exterior stairs leading out from the gym should be replaced.

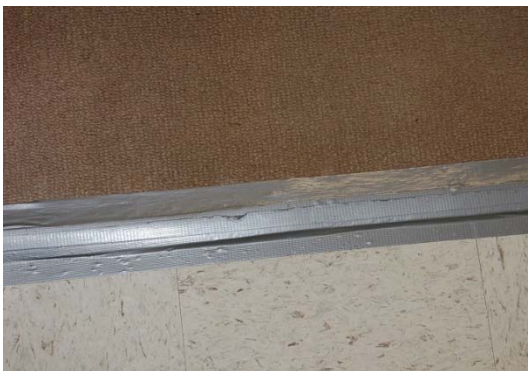
Thermal scan of exterior wall surfaces is recommended, particularly at roof to wall transitions and where potential thermal transfer occurs at steel framing.

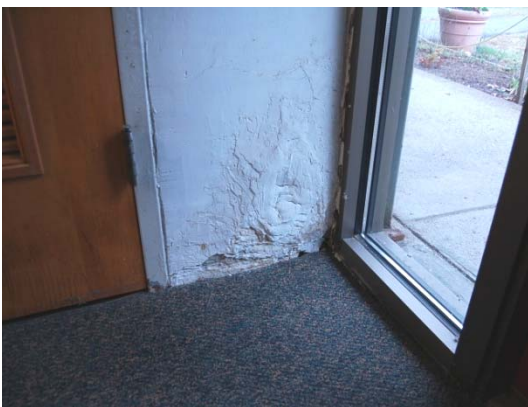
Wood handrails at exterior metal stairways should be replaced with steel.

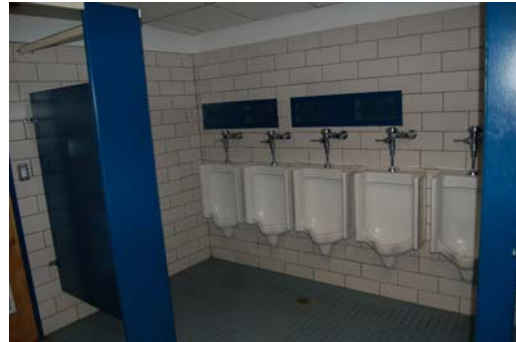
Carpeting in the Library and several spaces in the school is in good condition, while other areas, such as some classrooms in the 1968 wing are in fair condition with seams taped with duct-tape (Image 12).

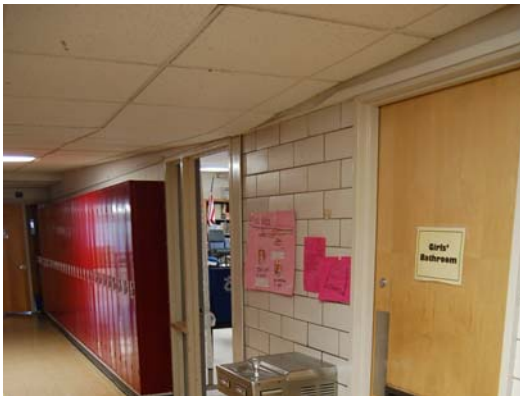
Multi-stall bathrooms are in need of upgrades, with poor lighting, bowed ceiling tiles, chipped ceramic mosaic tile, rusting metal partitions and sink/counters that are in poor condition (Image 14).

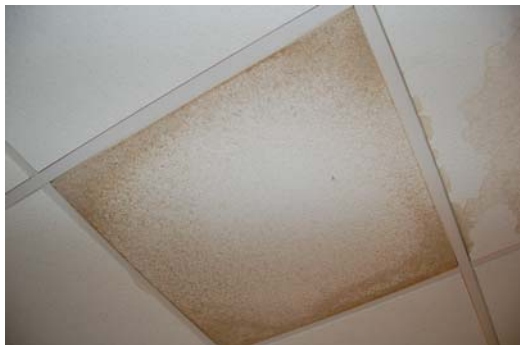
Doors throughout the school are primarily wood veneer with lever hardware. Doors in the 1958 building are in need of replacement, while the doors in the 1969 wing are generally in good condition. Some appear to have been replaced during subsequent renovations.

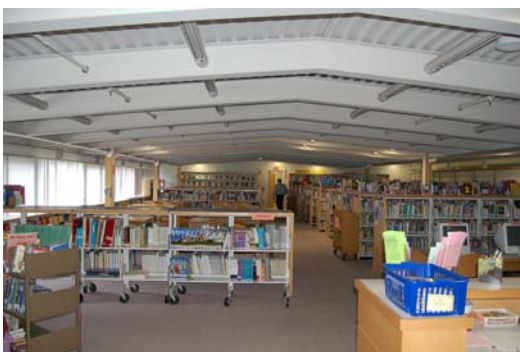
Brick infill is missing at corner of gym where there appears to have been a history of leaks around a roof drain (Image 15). The exposed structural steel framing within the brick wall should be reviewed prior to infilling. Brick should be infilled where it is missing.

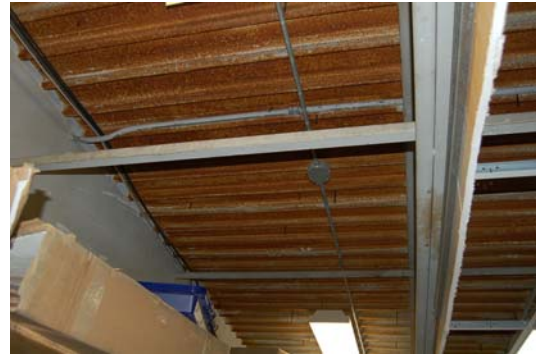
When renovations are planned, it is recommended that both layers of floor tile (VCT and VAT) are removed, the entire floor flash-patched and new VCT

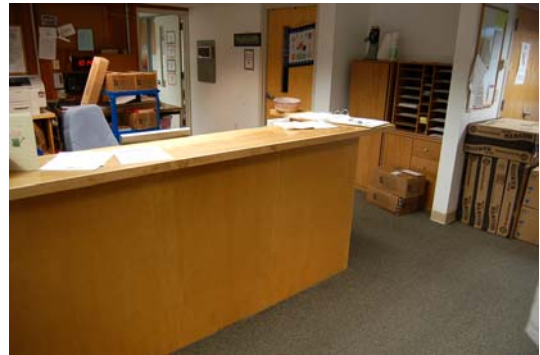
1. Lack of proper lavatory faucet handles
2. Lack of insulation on piping below sinks
3. Grab bars are not long enough (42” length req’d) or missing (Image 26)
4. Lack of turning radius/clear space at some toilet room doors (Image 27)
5. HC accessible lockers were not observed

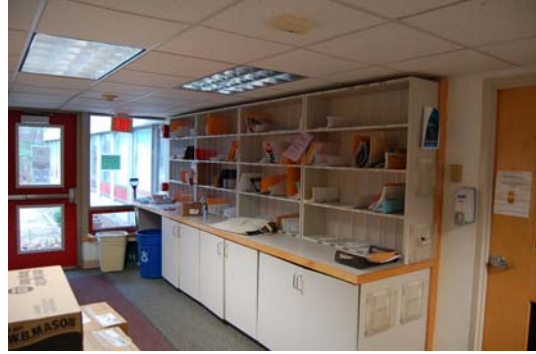
the community to access various spaces throughout the school independently. Disabled people may include students with a permanent handicap condition, students that are temporarily disabled from athletic activity, parents or other visitors that could have any form of disability. Any form of renovation plan should incorporate the accessibility of these items to accommodate disabled people to the fullest extent possible.

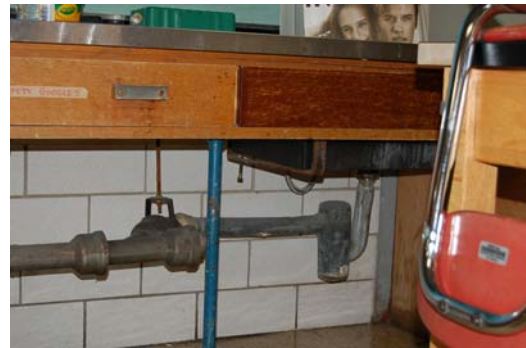
Most built-in casework has plastic laminate with hardwood edge and appears to be in good condition (Image 36). Entry desk has wood veneer and is in very good condition.

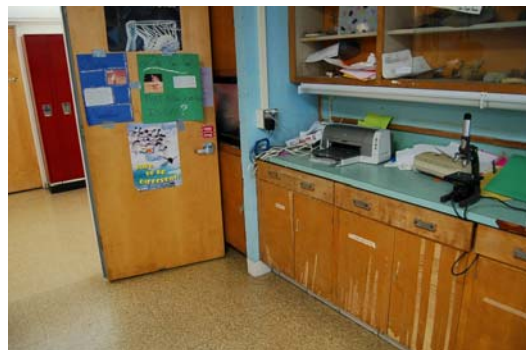
Science lab casework in 1958 wing are in very poor condition (Images 37, 38, 39). Some sinks are no longer used; gas has been disconnected. Casework in the Science labs in 1968 wing appear to be in better condition but should also be considered for replacement.

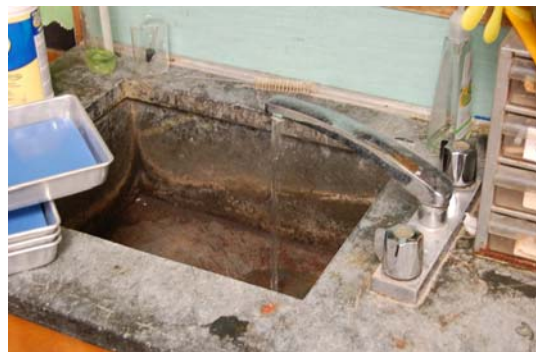
Classrooms in the 1968 wing have built-in book cases along the perimeter of the room, with plastic laminate tops and hardwood edges; these appear to be in good condition.

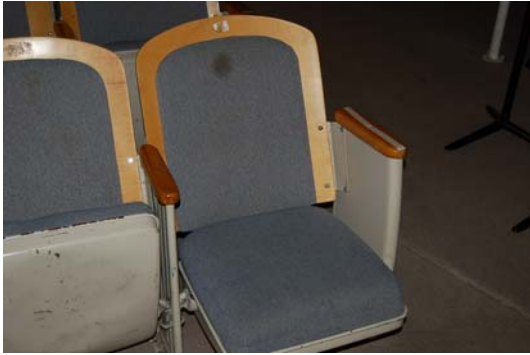
Auditorium seats are in fair to poor condition; many of the springs have failed, some seats are missing, and some seat backs are broken (Image 40). For the amount of use these seats have received over the past 40+ years, they have served their useful life.

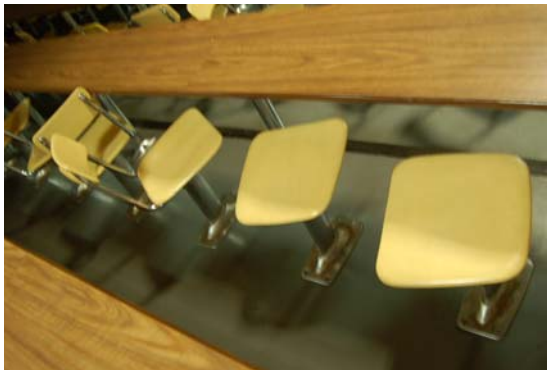
Folding partition in the gym is in poor condition and does not appear to be used any longer (Image 42).

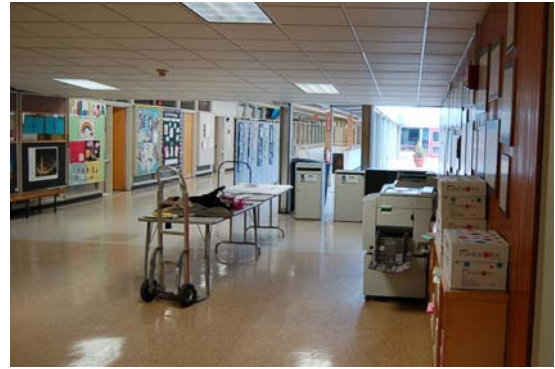
- The Wood shop and Art spaces in the 1969 wing are pleasing spaces, with skylights and high ceilings.
- There appears to be a lack of administrative work space available as the lobby area is used for copying and work-table for administrative staff and/or faculty (Image 44).

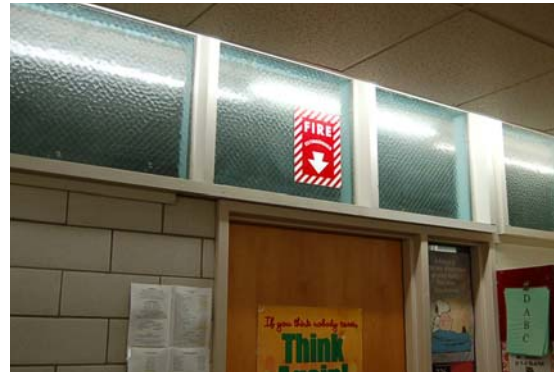
When long-range educational programming is being considered, we recommend that an assessment on the current use of space be included in that process. A review of the Science classrooms was conducted as part of this study as this was identified as a focus area. Conceptual options for addressing the Science classrooms were prepared with input from school officials and are identified in another section of this study.

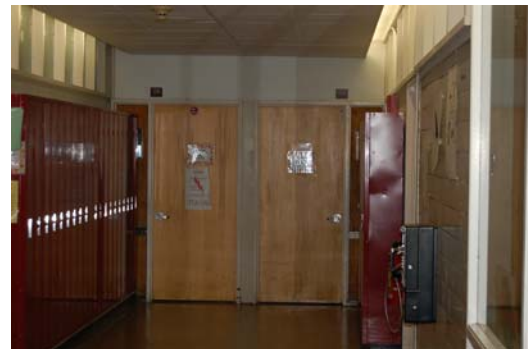
1. Fire extinguisher signs pointing to the location of fire extinguishers that were either not there or located within a locked room (Image 45).
2. Exposed wiring visible in corridor where old pay tel. was located. A cover plate should be provided.
3. Doors from corridors to classrooms do not have closers; doors should be equipped with closers to provide a smoke separation.
4. There is a 60' dead-end condition at rooms 262 to 264 and at several other locations in the building (Image 46). With a fully-sprinklered building, these conditions may be alleviated.
5. It was noted that unit ventilators were covered with books or projects in various classrooms. It is recommended that these are removed to allow for air to flow freely into the space.

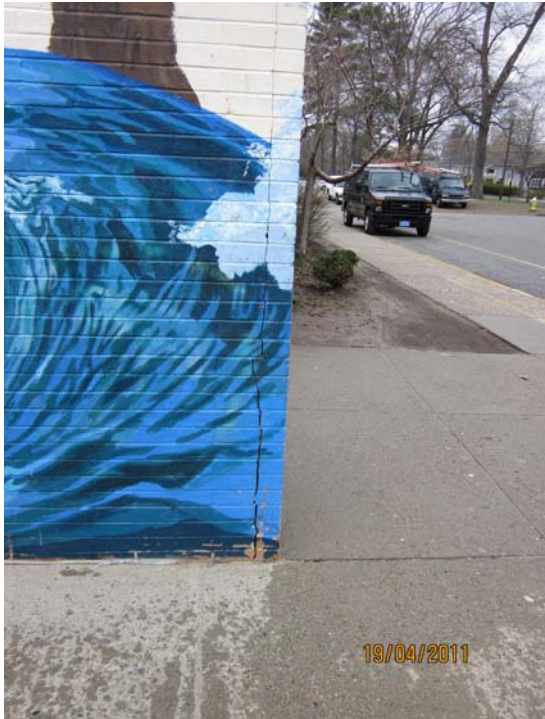
Photo 1: Brickwork cracking and decay at brick/pavement interface.

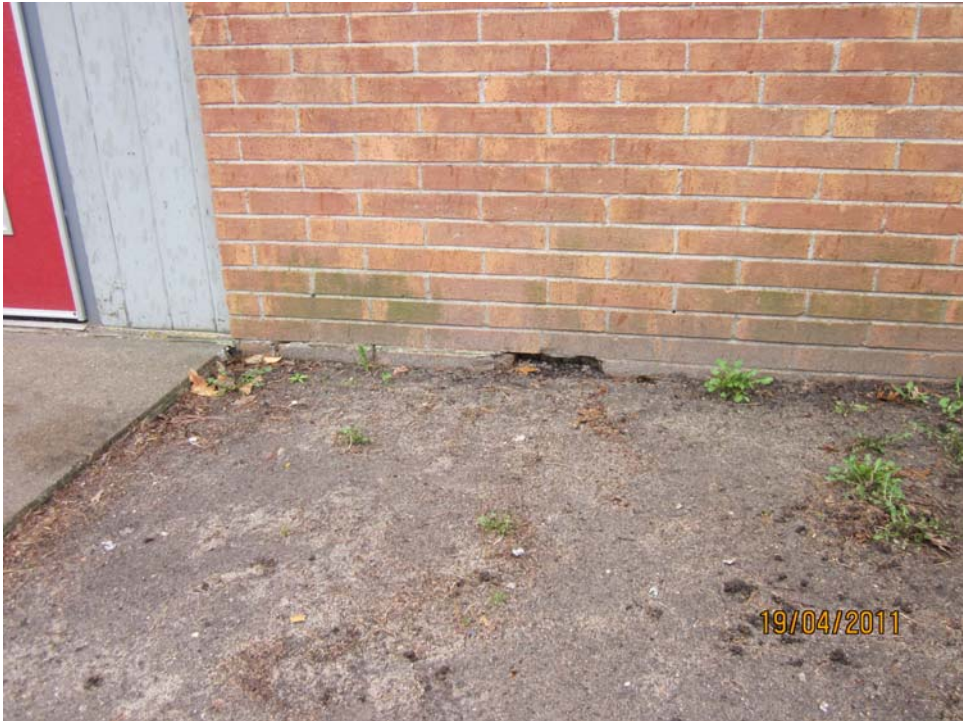
Photo 2: Brickwork cracking and decay at brick/pavement interface.

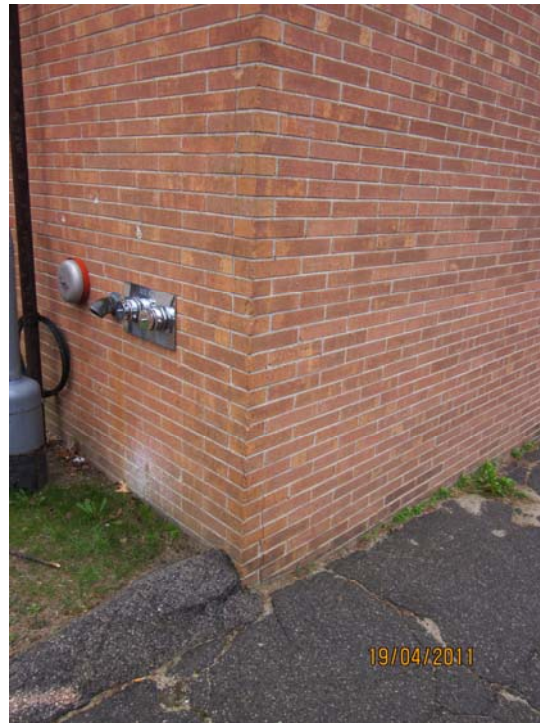
Photo 3: Brickwork cracking and decay at brick/pavement interface.

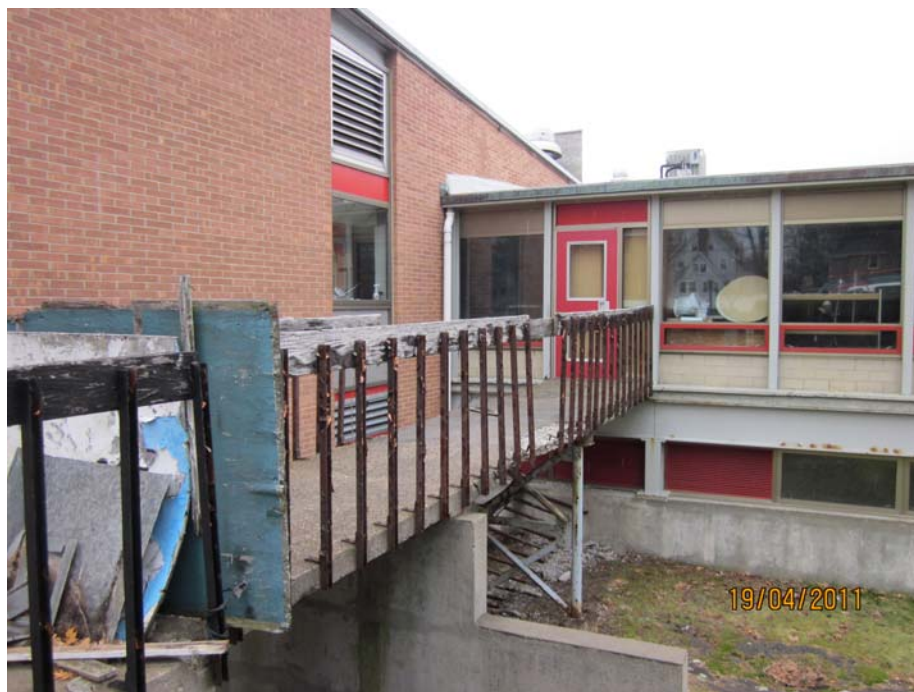
Photo 4: Corroded concrete and steel at bridge on west side of auditorium.

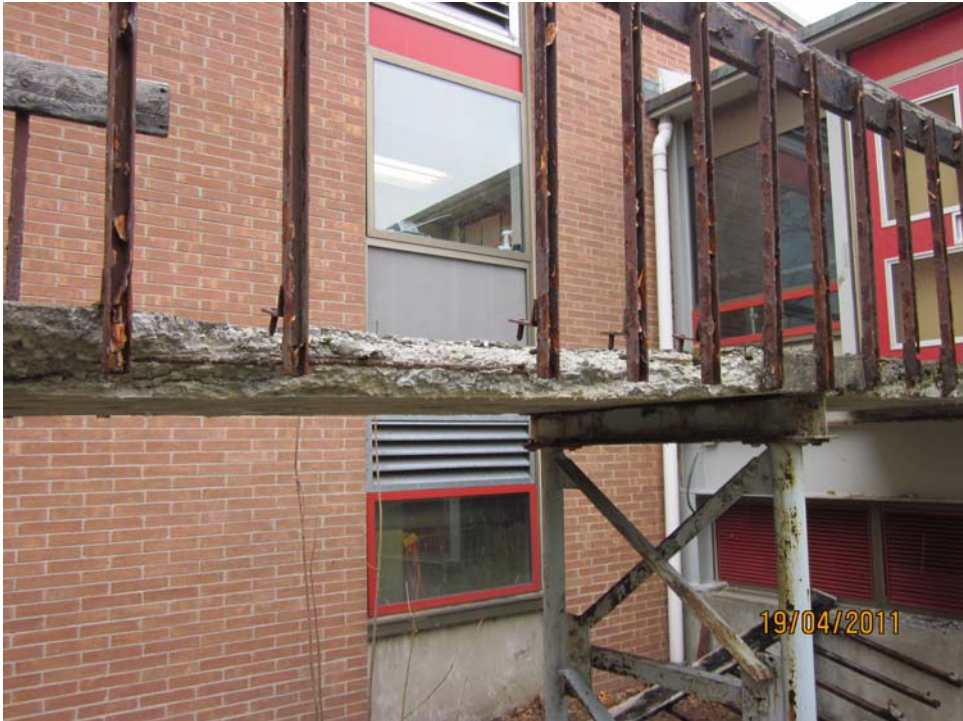
Photo 5: Corroded concrete and steel at bridge on west side of auditorium.

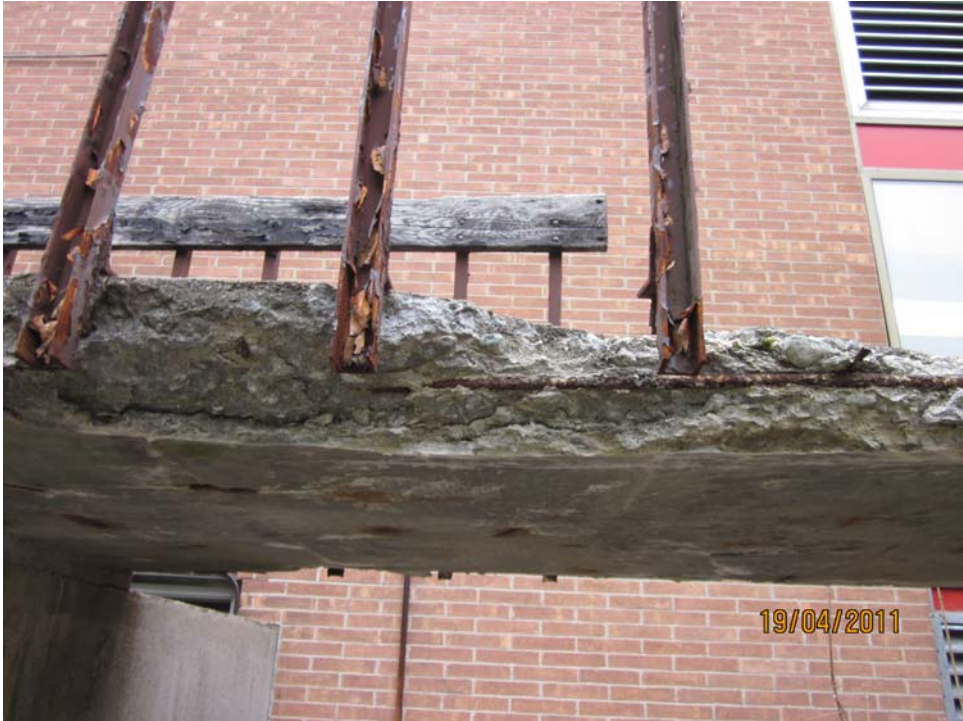
Photo 6: Corroded concrete and steel at bridge on west side of auditorium.

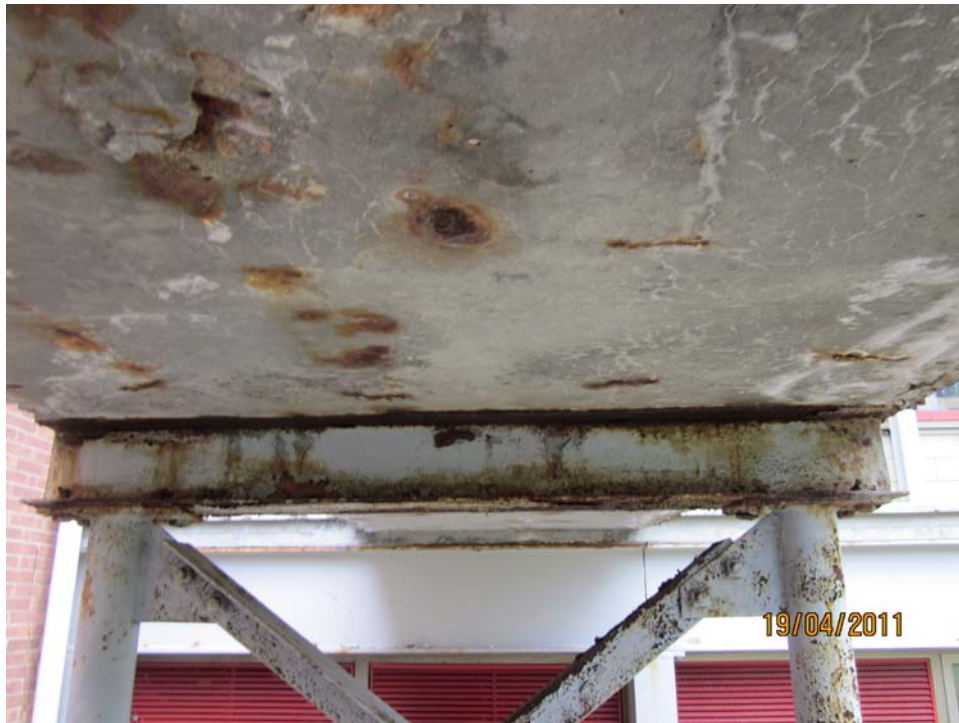
Photo 7: Corroded concrete and steel at bridge on west side of auditorium.

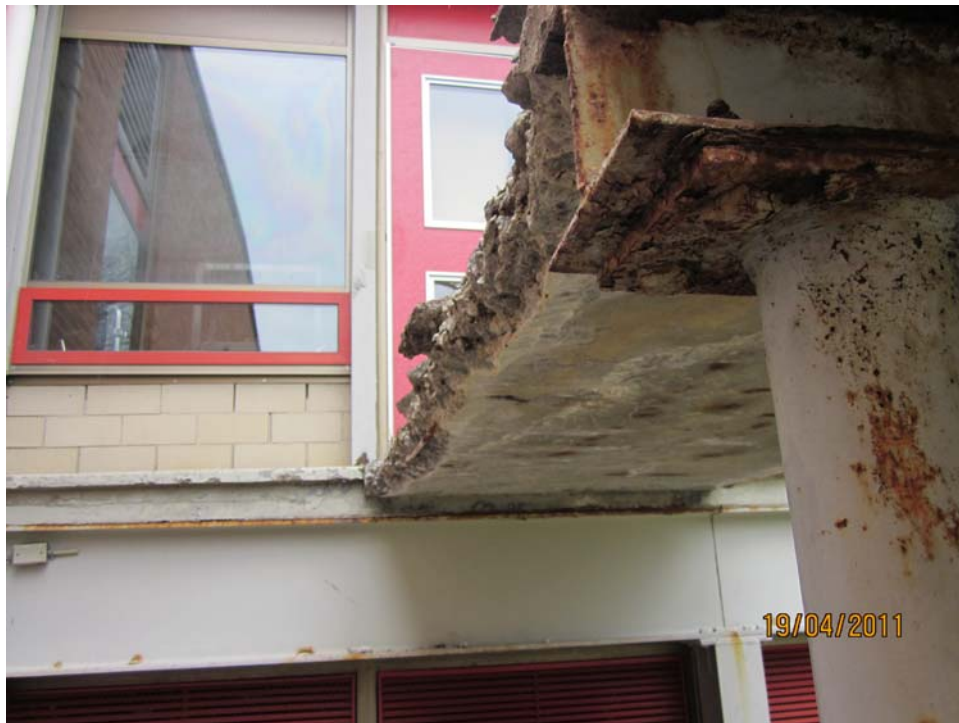
Photo 8: Corroded concrete and steel at bridge on west side of auditorium.

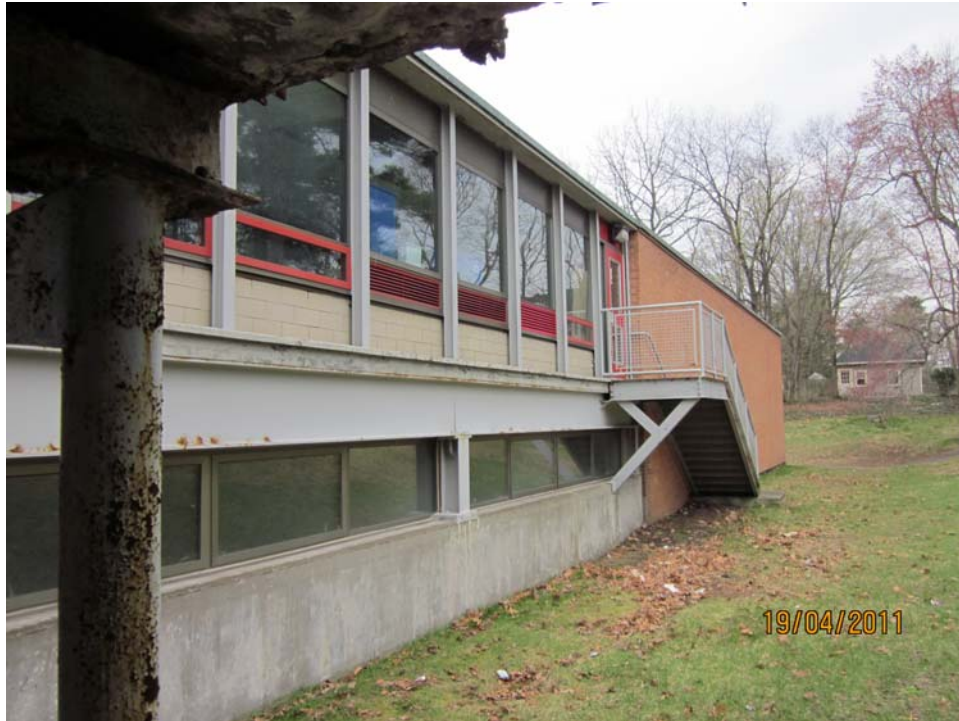
Photo 9: Corroded concrete and steel at bridge on west side of auditorium.

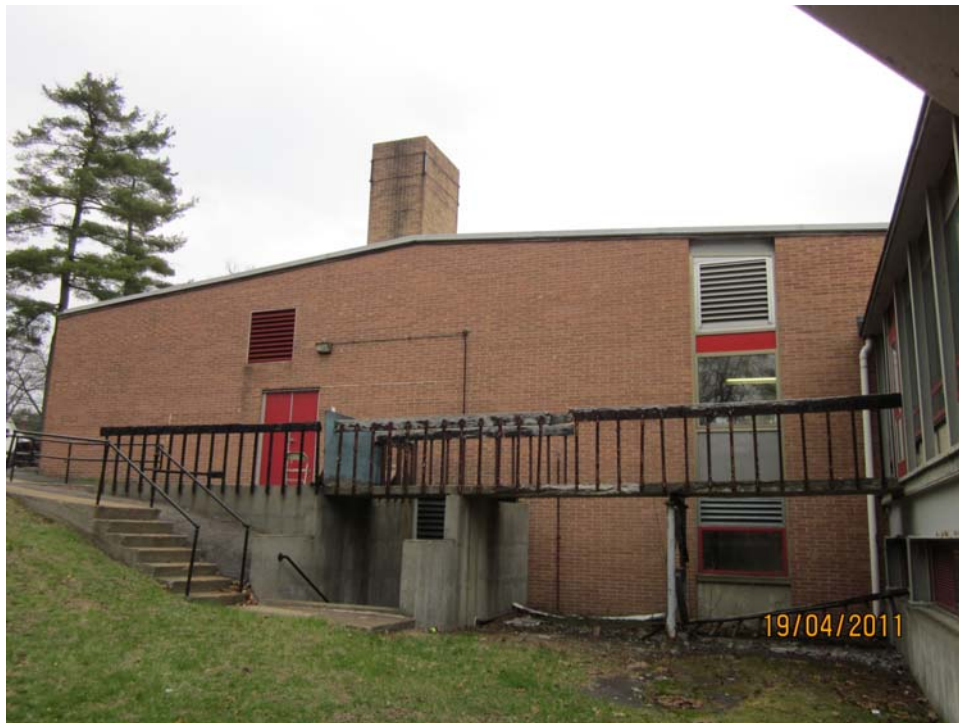
Photo 10: Corroded concrete and steel at bridge on west side of auditorium.

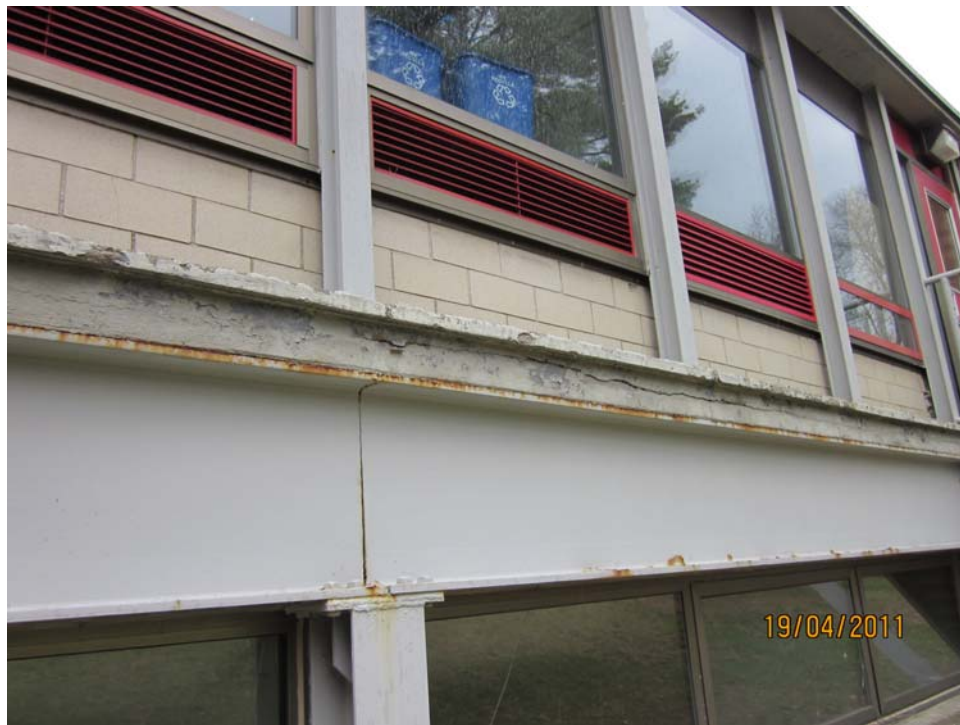
Photo 11: Slab cracking due to moisture and corrosion at exterior of band room.

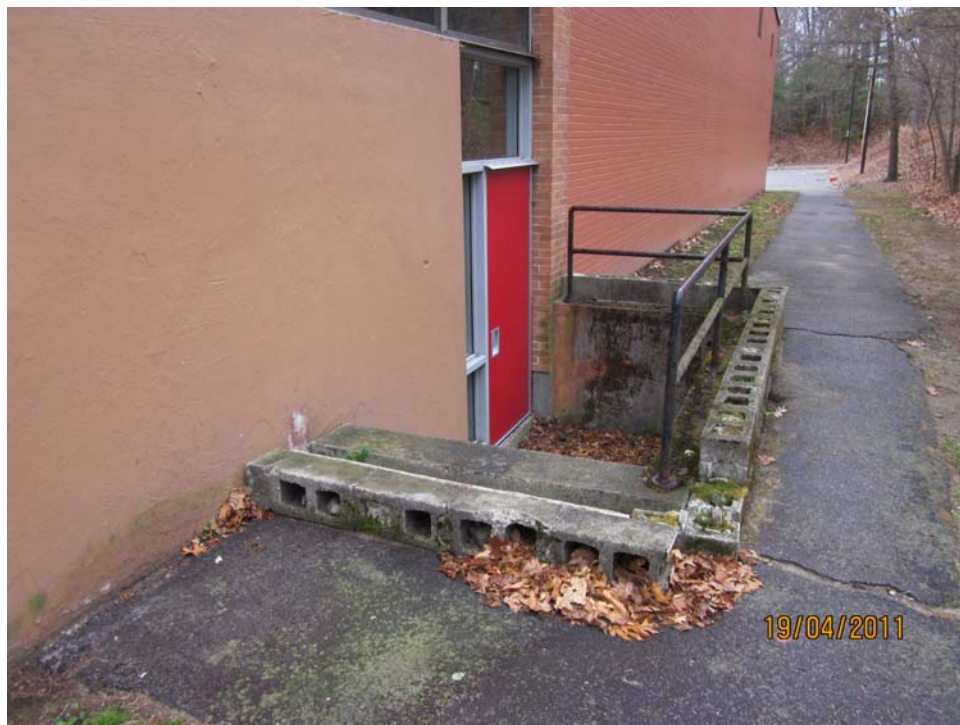
Photo 12: Areaway condition at southwest corner.

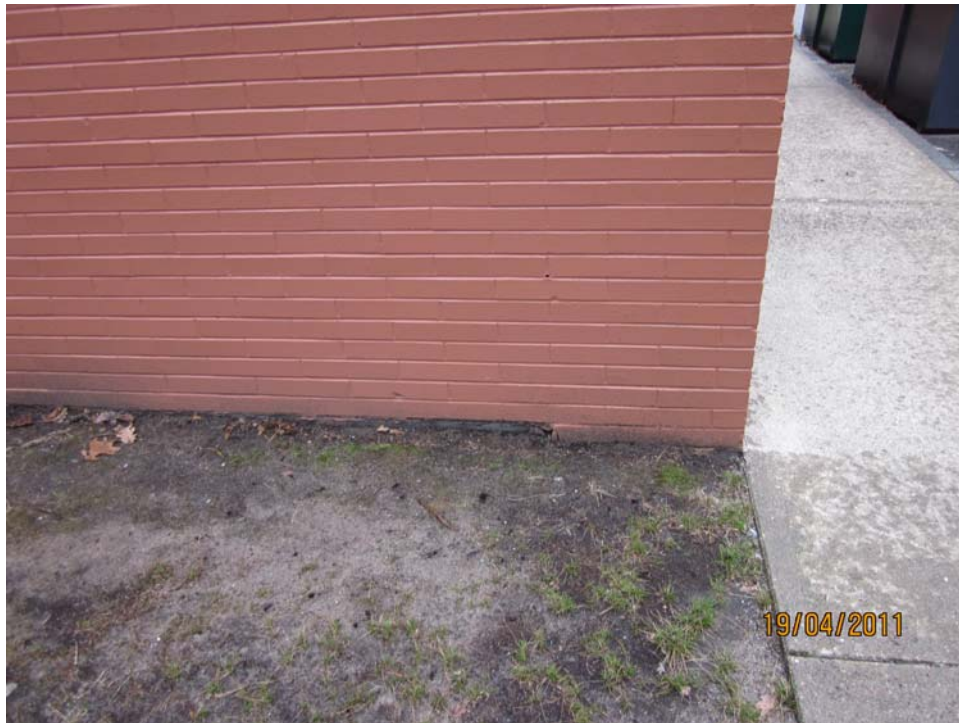
Photo 13: Decay at brick/sidewalk interface at southwest Gymnasium Two corner.

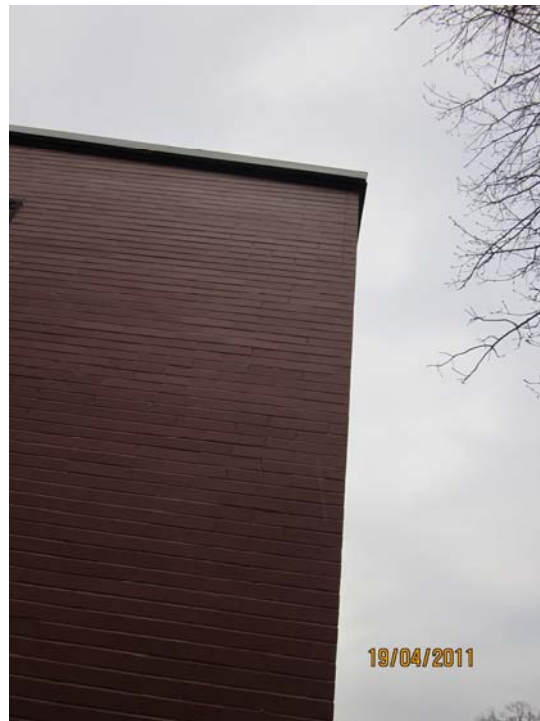
Photo 14: Localized bowing of brick at southwest Gymnasium Two corner.

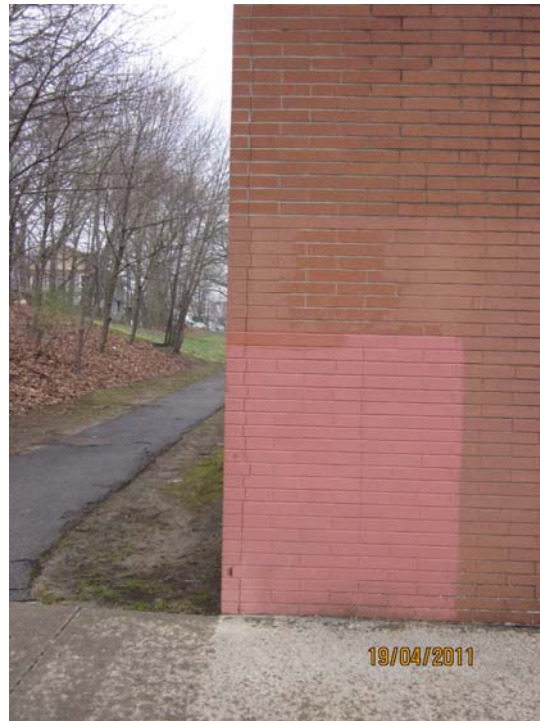
Photo 15: Brick cracking at southwest Gymnasium Two corner.

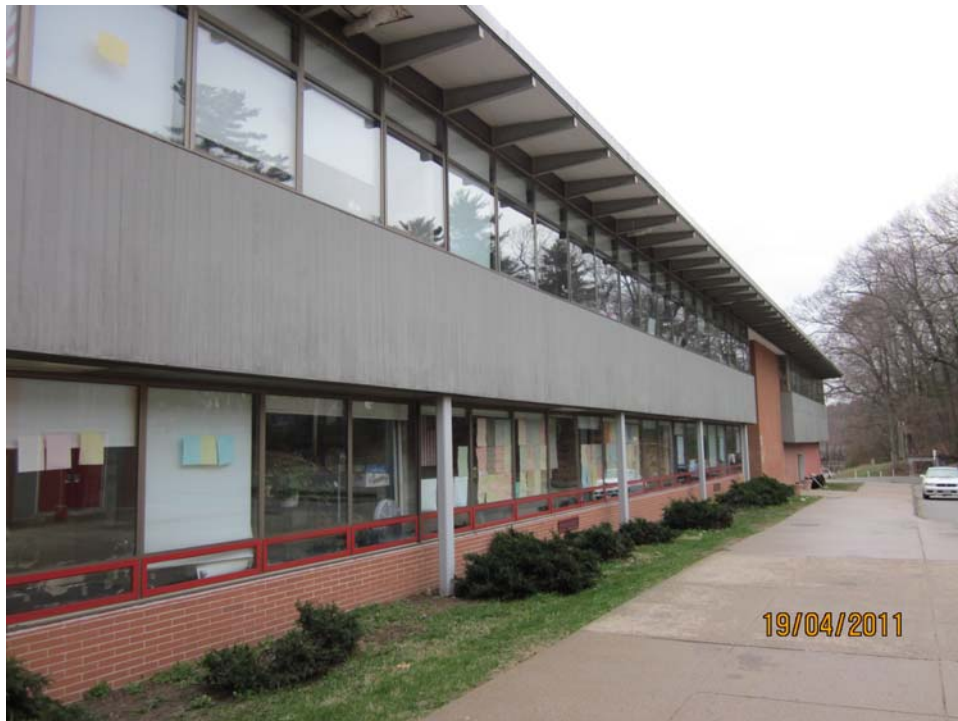
Photo 16: Condition of two story academic wing.

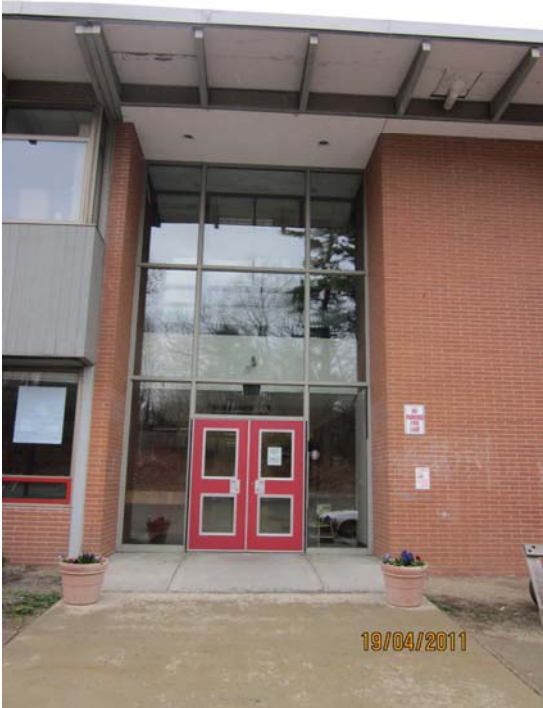
Photo 17: Two story curtain wall at door.

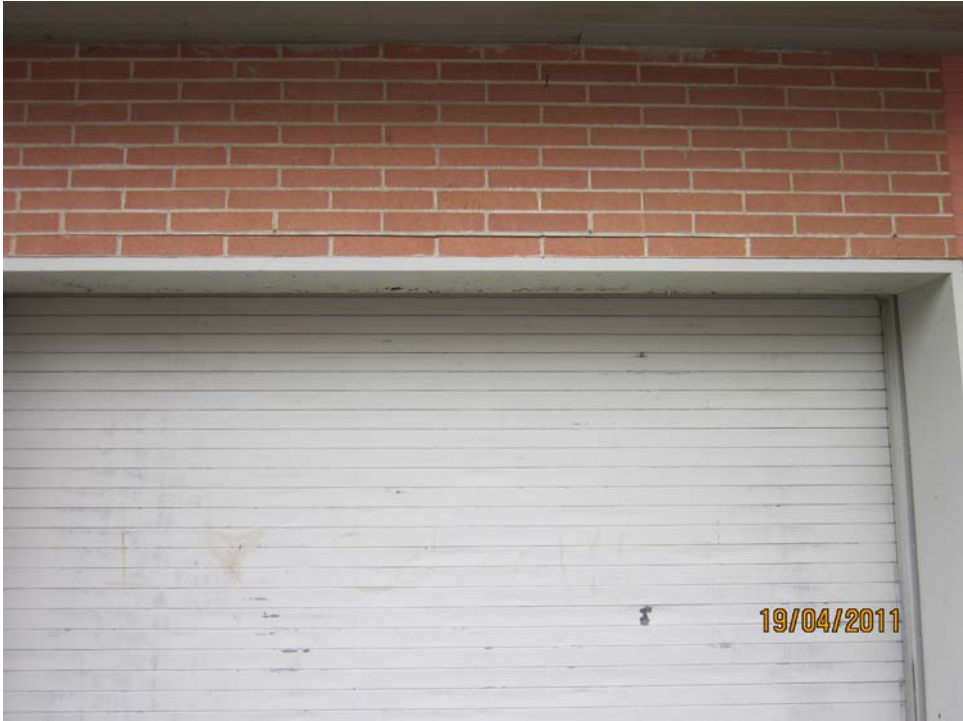
Photo 18: Brick cracking at course above overhead door in receiving.

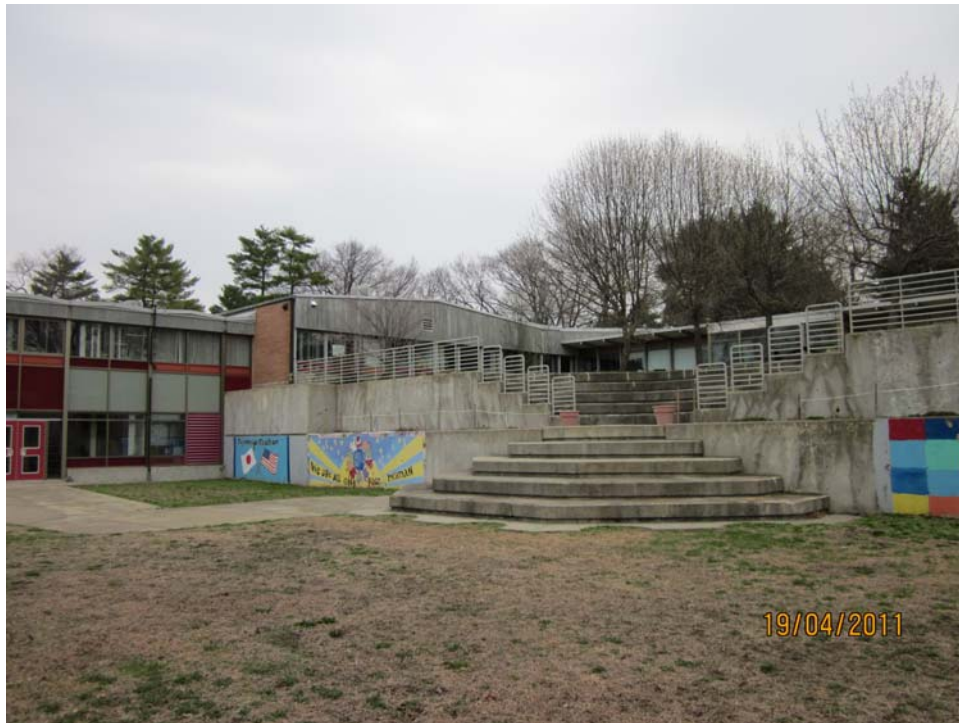
Photo 19: Condition of amphitheater concrete.

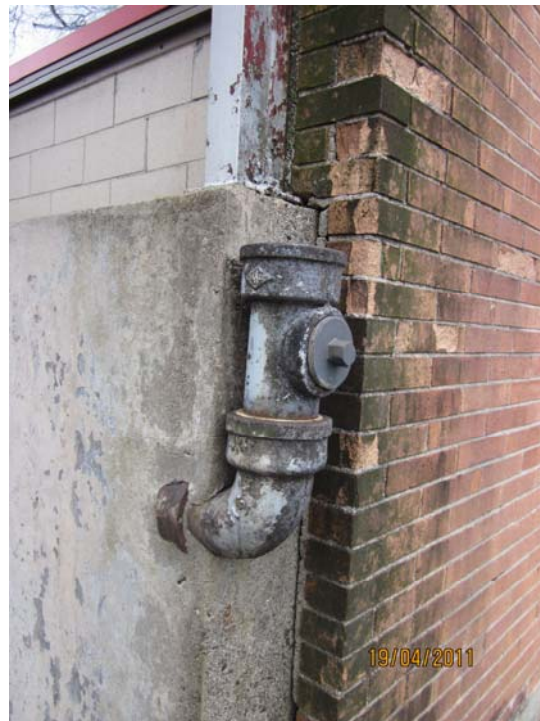
Photo 20: Brick distress at south corners of single story academic wing caused by rain leader problems.

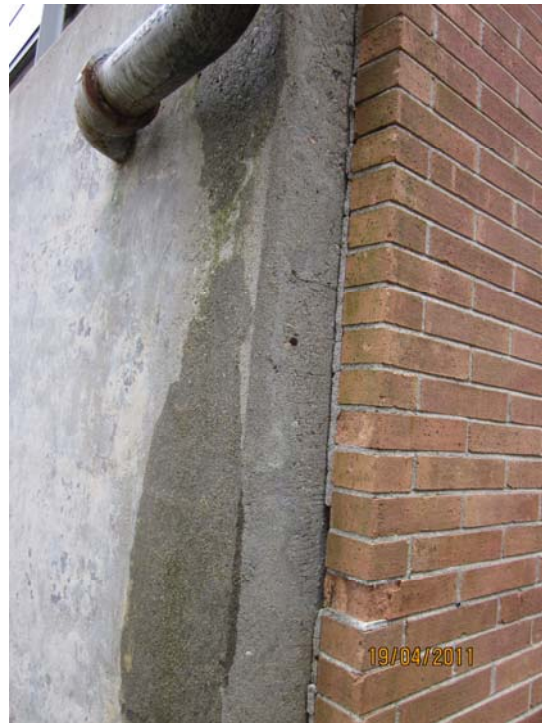
Photo 21: Brick distress at south corners of single story academic wing caused by rain leader problems.

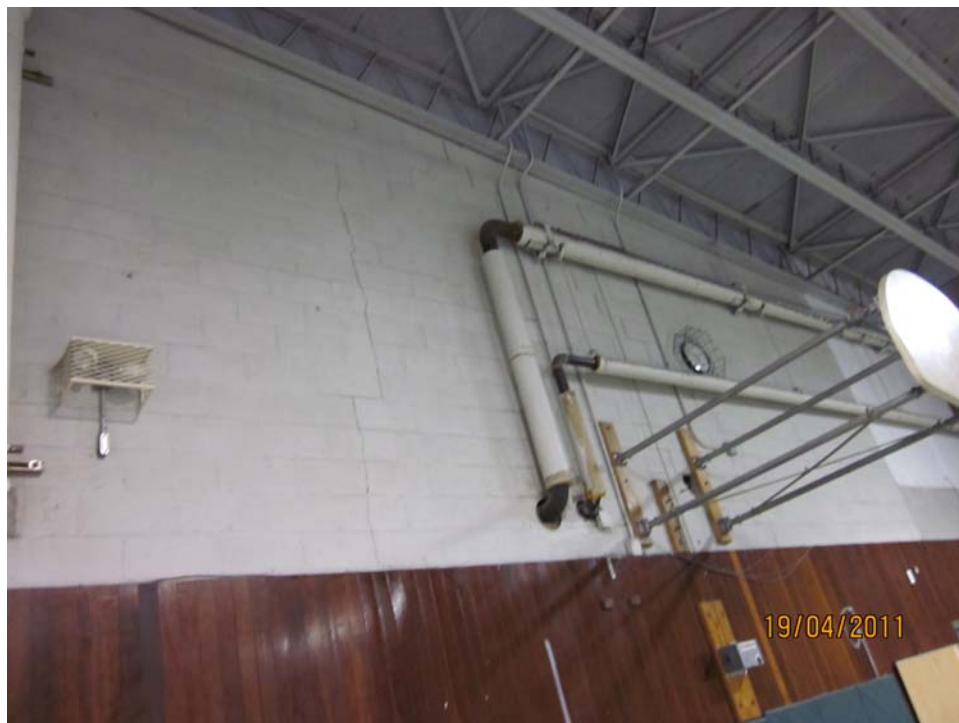
Photo 22: Interior block cracking at the gymnasium.

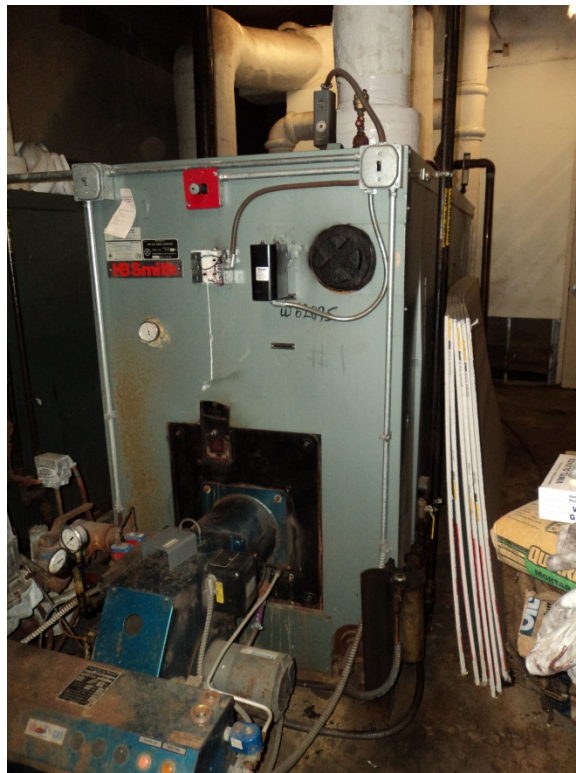
Typical Existing Hot Water Boiler

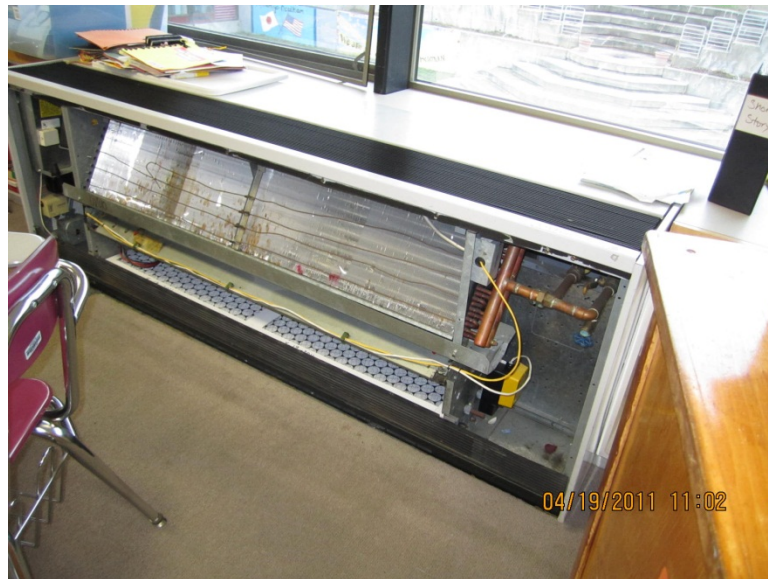
Unit Ventilator With Front Cover Removed

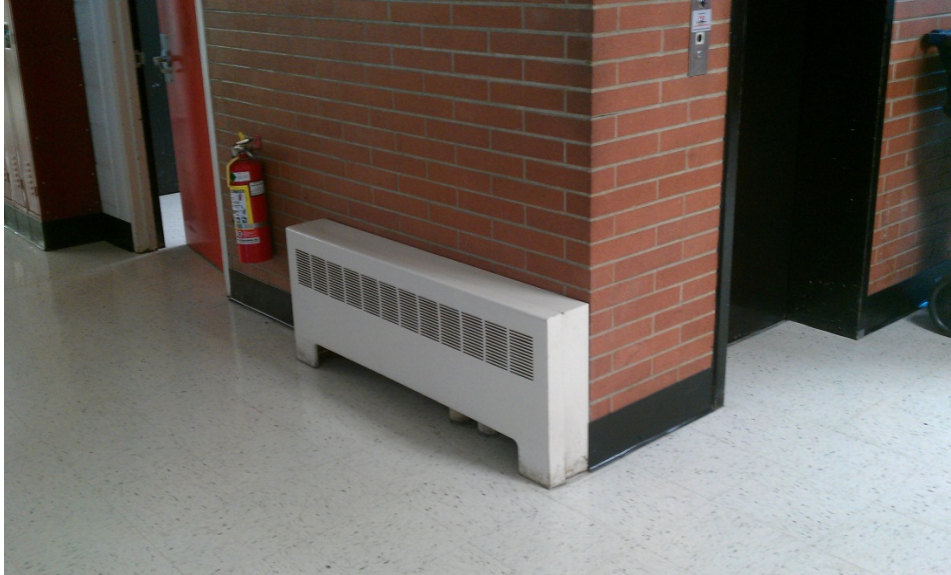
Finned Tube Radiator

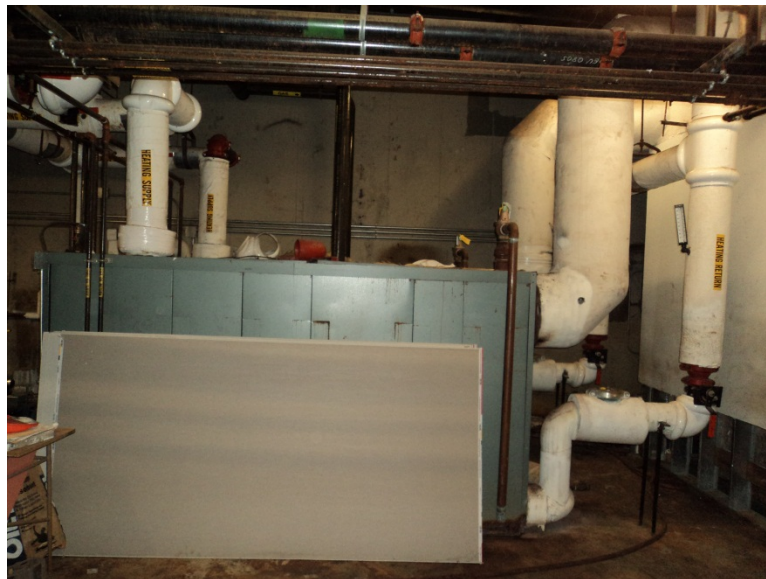
Existing Hot Water Boiler With Insulated Piping

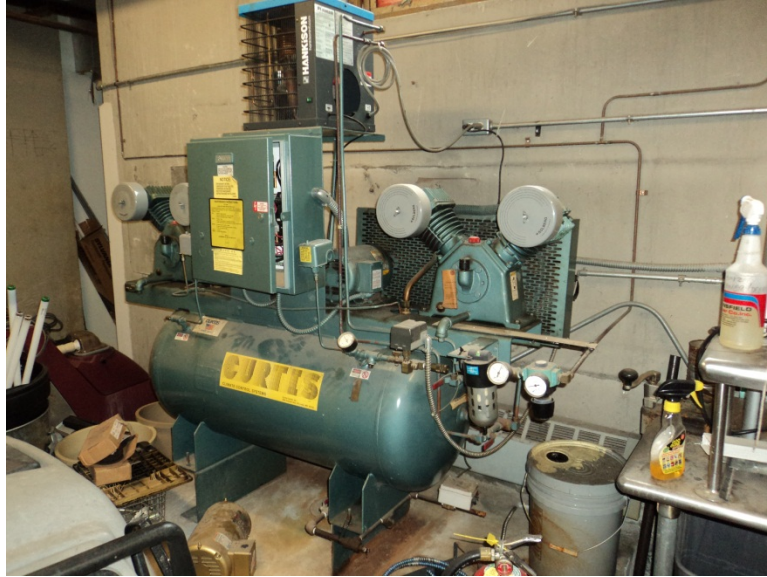
Pneumatic Controls Compressor

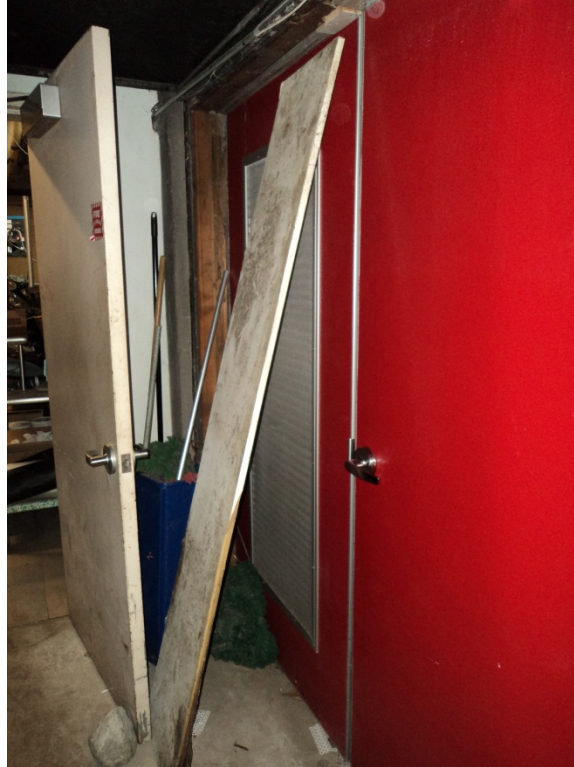
Boiler Room Combustion & Ventilation Air Intake Louver

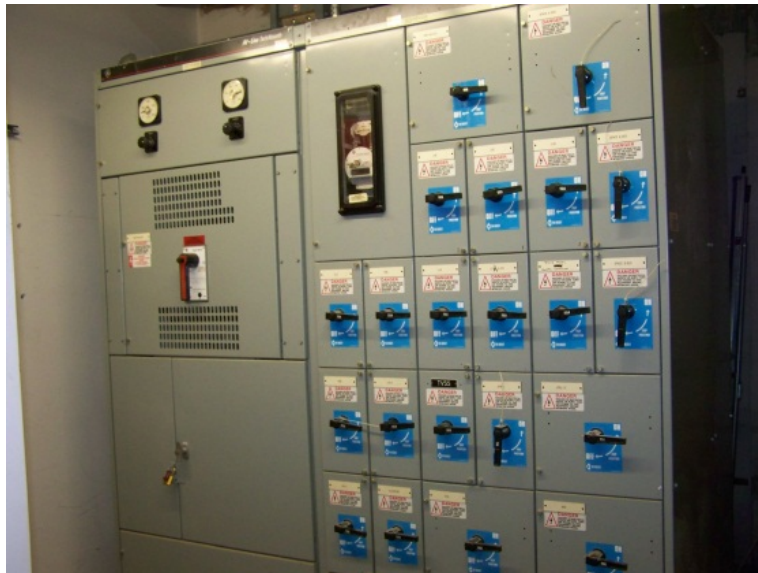
Main School switchboard
