CIVIL ASSESSMENT

Nitsch Engineering's observations and findings are summarized below.

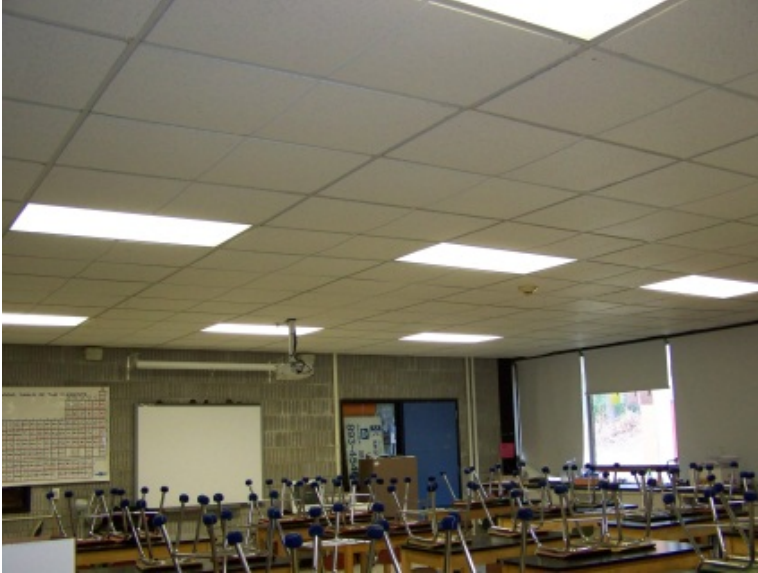
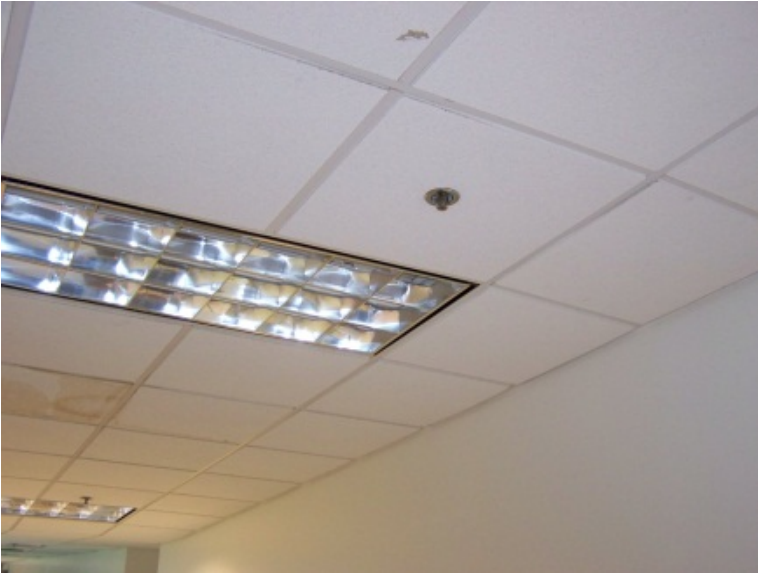
Typical Fluorescent Fixtures

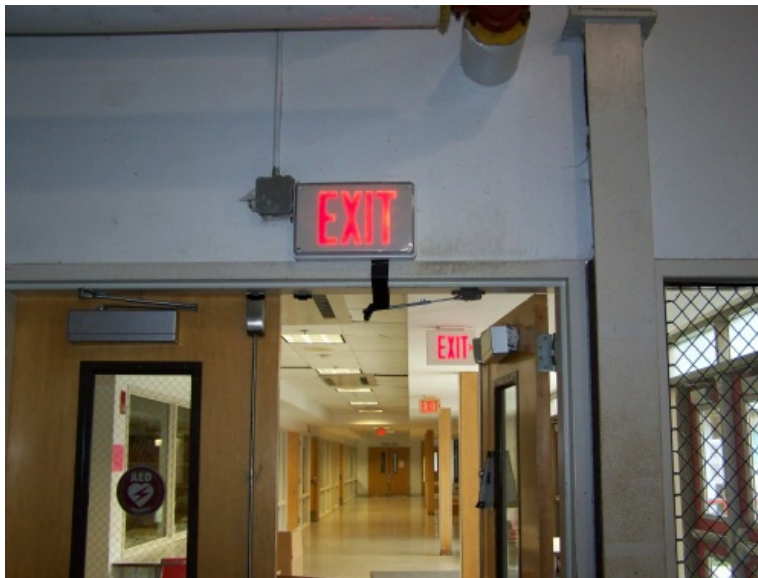
Typical Egress Lighting and Exit Signs

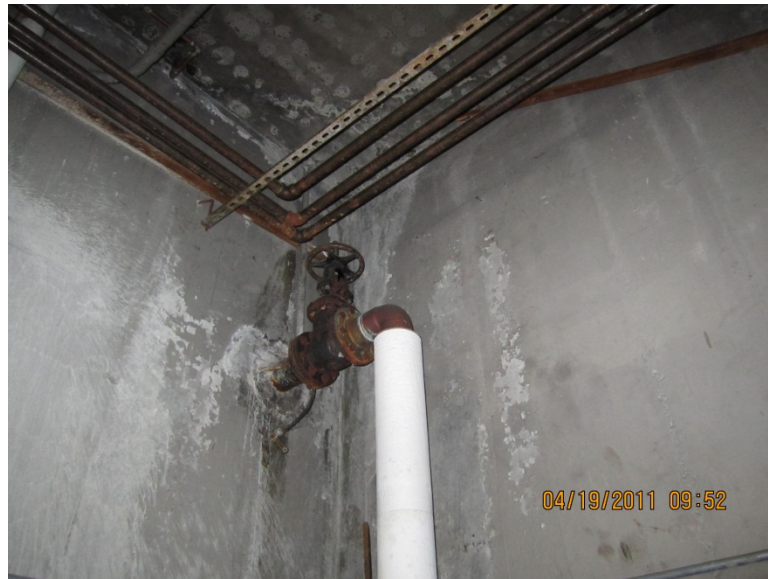
A four inch water service from Harris Avenue enters the boiler room of the 1956 wing and appears to be original to the building's construction. The service stubs through the foundation wall overhead and has a flanged OS&Y main shut-off valve.

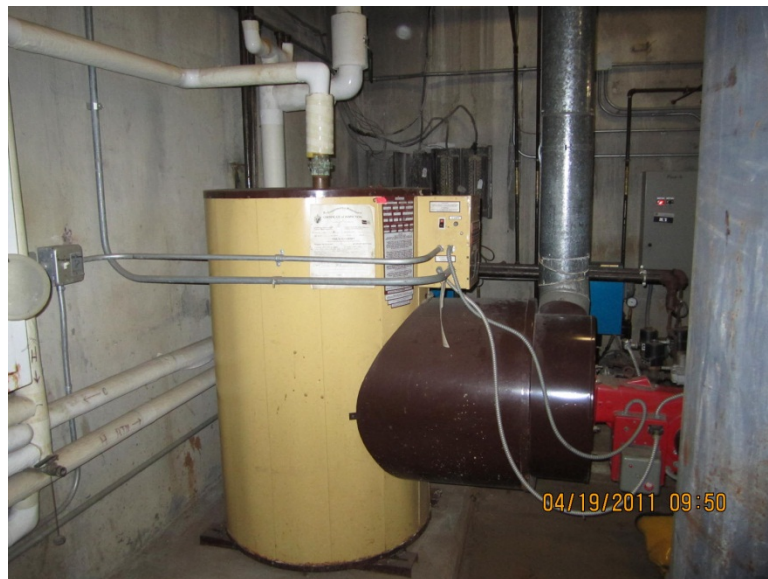
Domestic Water Heater

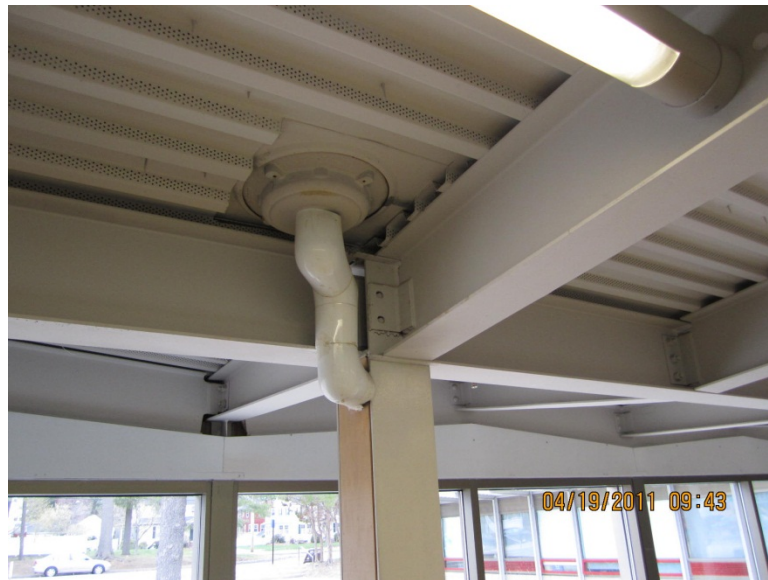
Interior storm drainage is mainly run exposed. Typical examples include the corridor along Harris Ave and in the library. Most of the piping appears to have been replaced during the 1992 renovation placing it at about 19 years old. Other areas such as within and outside the gymnasiums appears to be original and is cast iron with lead and oakum joints with some minor repairs.
